Ryobi P202 Bit Storage Clip Replacement

How to replace the Bit Storage Clip on the Ryobi P202 power drill.

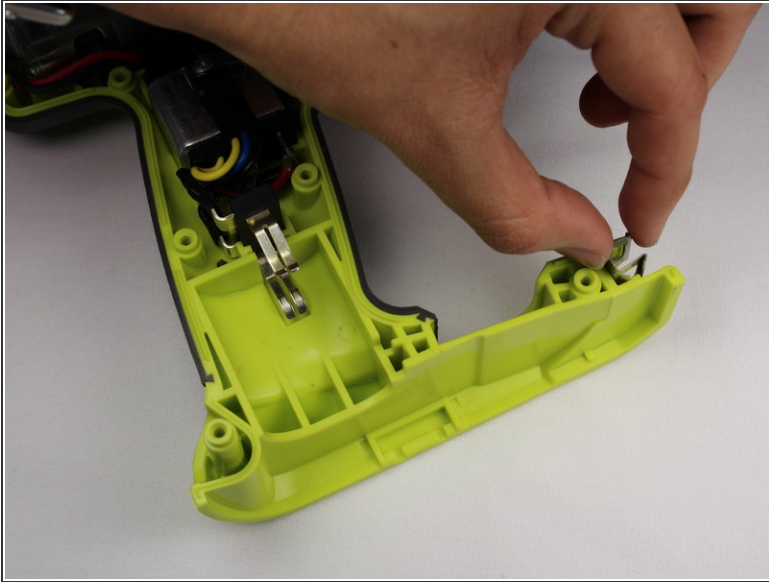
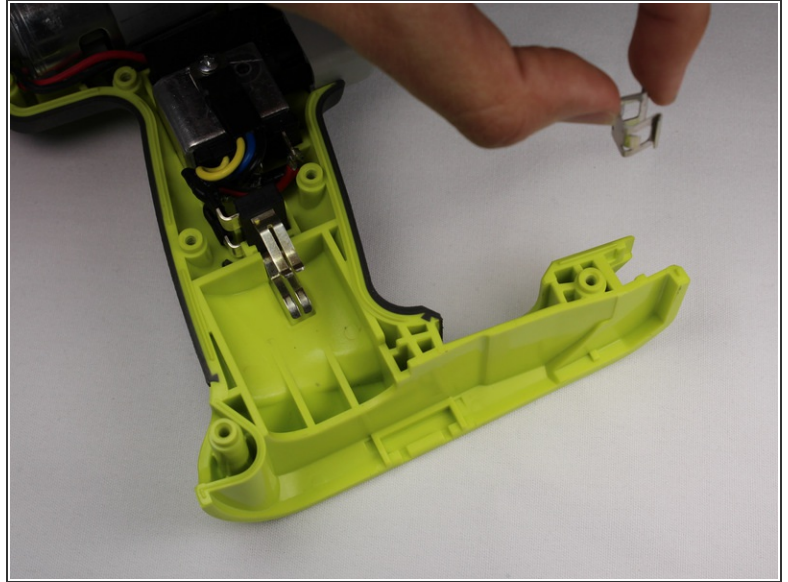
Step 4 — Bit Storage Clip

- Grip the bit-clip and gently lift up to remove it from the case.

The bit-clip is Part #: 630206007
